Arboricultural Review

979 Crestvalley Road
Atlanta, GA

Date: 2/17/2010

Objective: To review trees and shrubs located on site for pests and pathogens. The tree are also to be reviewed for structural concerns.

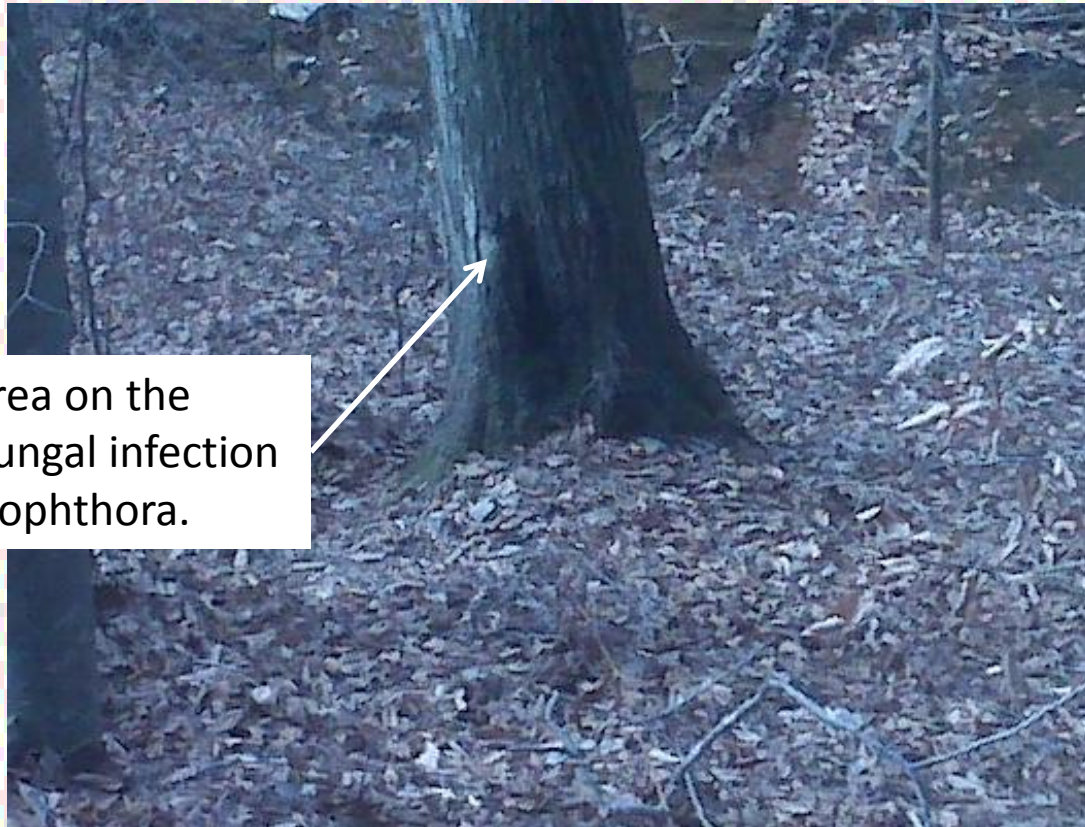
The first is an Oak located on the street side of the creek. The lower trunk has a “wet” spot called Phytophthora. This pathogen is a good indicator of stress and can lead to vascular system shut down resulting in death.

The dark area on the trunk is a fungal infection called Phytophthora.

Three of the four oaks located in the front yard are stressed from the construction. Construction can impact trees for seven to ten years after its completed. The recommendation here is to improve soil fertility concentrations and to apply a tree growth regulator. Fertility will increase the efficiency of the root system and the growth regulator will take the energy normally used for growth and divert it to be used for self defense and root growth. The oak located by the road will eventually need removal because the effects of basal decay can not be reversed. The application of the growth regulator can add years to the decline cycle but is not a permanent solution to the inevitable.

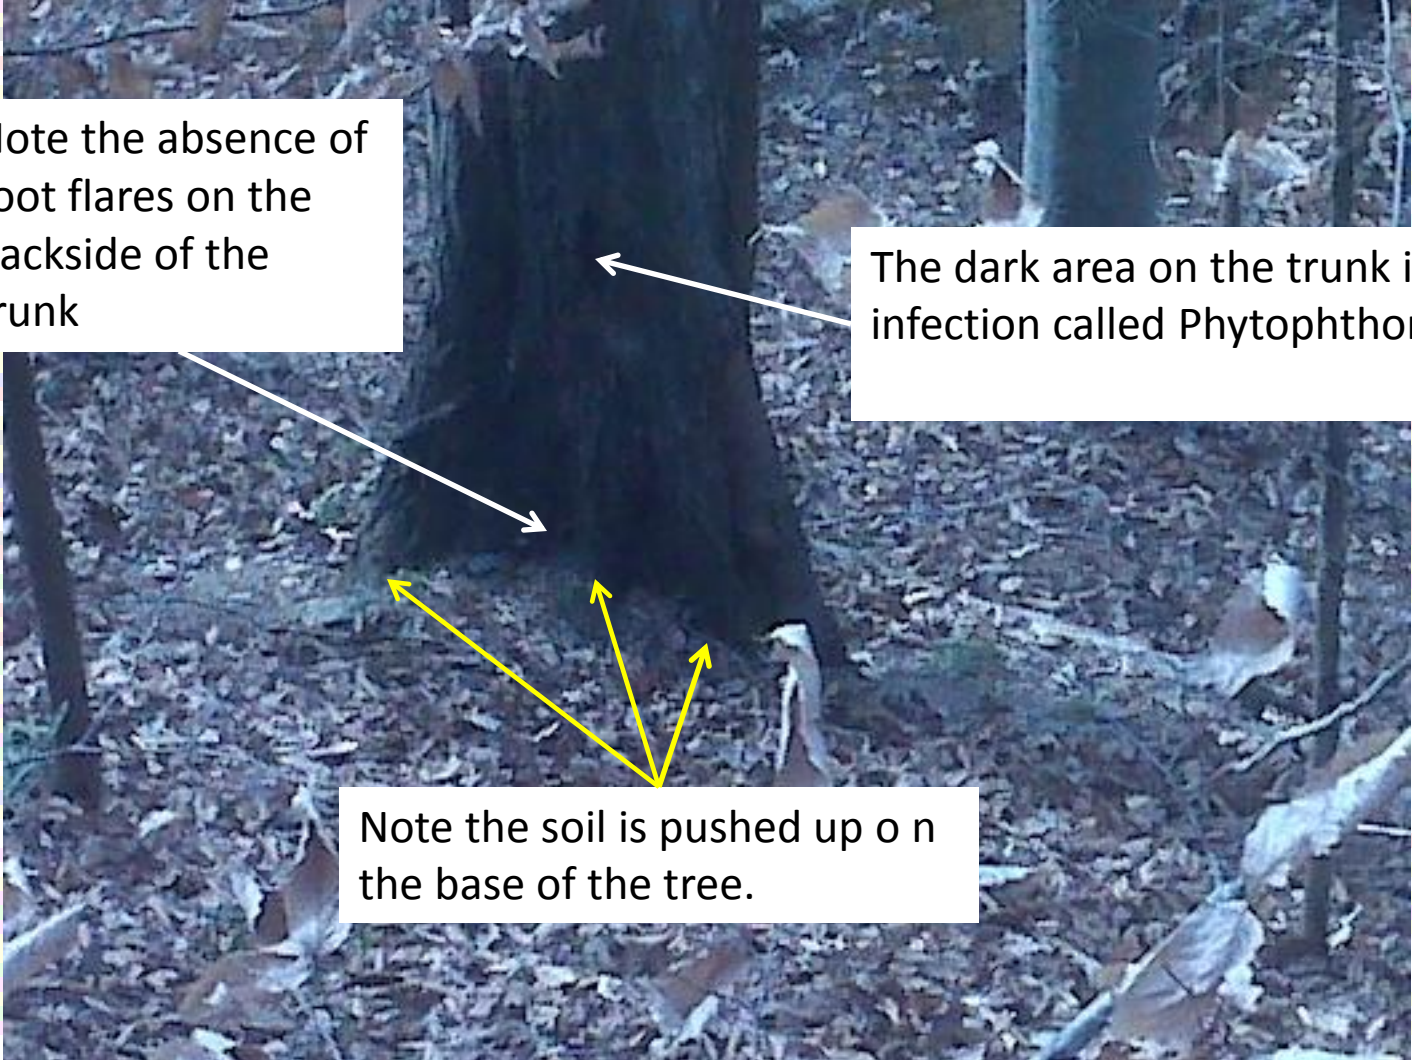
The second tree also has Phytophthora. The problems with this oak are compounded by poorly formed trunk flares and soil deposition over the compression plate. The trunk flares are a genetic defect that can lead to structural failure over time. During the construction of the main drive it seems that soil shifted down the hill covering the tree's roots.

Note the absence of root flares on the backside of the trunk

The dark area on the trunk is a fungal infection called Phytophthora.

Note the soil is pushed up on the base of the tree.

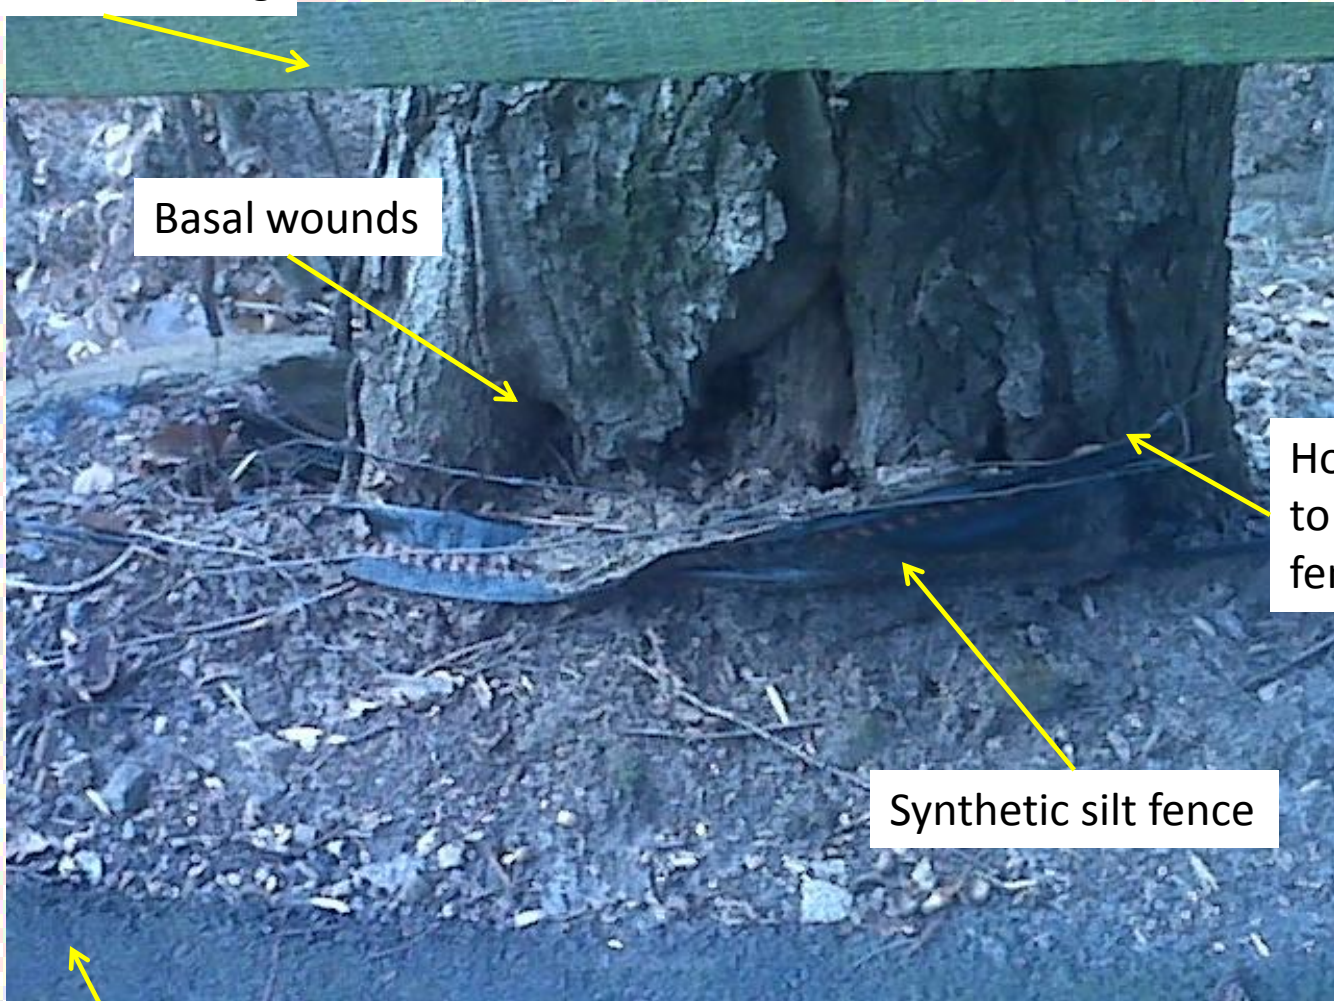
The third tree is located by the main drive. The problems with this oak are caused by construction. The basal wounding was created by road bed development. The erosion control devices are still present. The basal wounds are beginning to decay and will eventually create a hazardous situation.

Basal wounds

Hog Wire used
to back the silt
fence

Synthetic silt fence

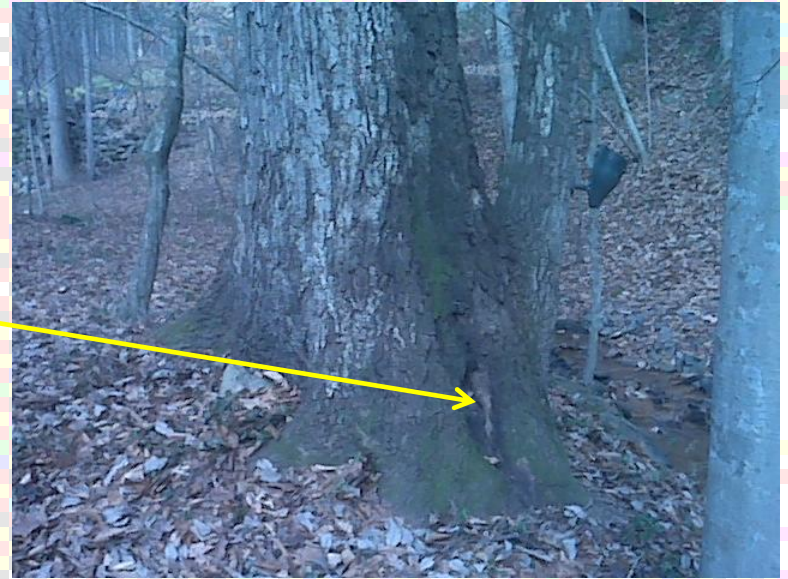
The fourth tree is located on the island formed in the front yard by the creek. This tree has some basal decay and poor branch formation.

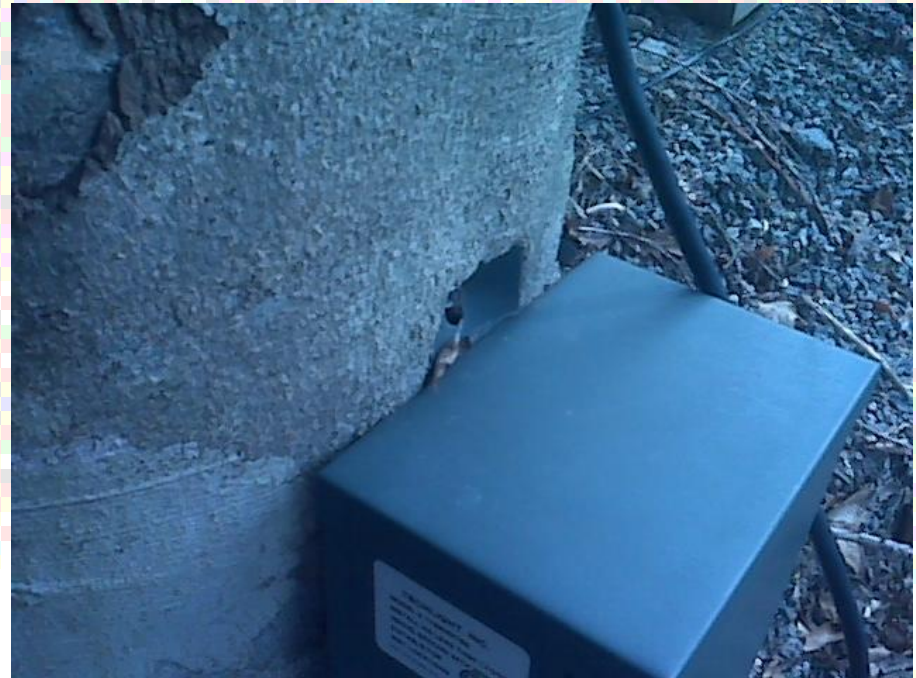
Several cultural problems were also observed. The lighting was not placed on standoffs and are now damaging the cambium layers on the tree trunks.

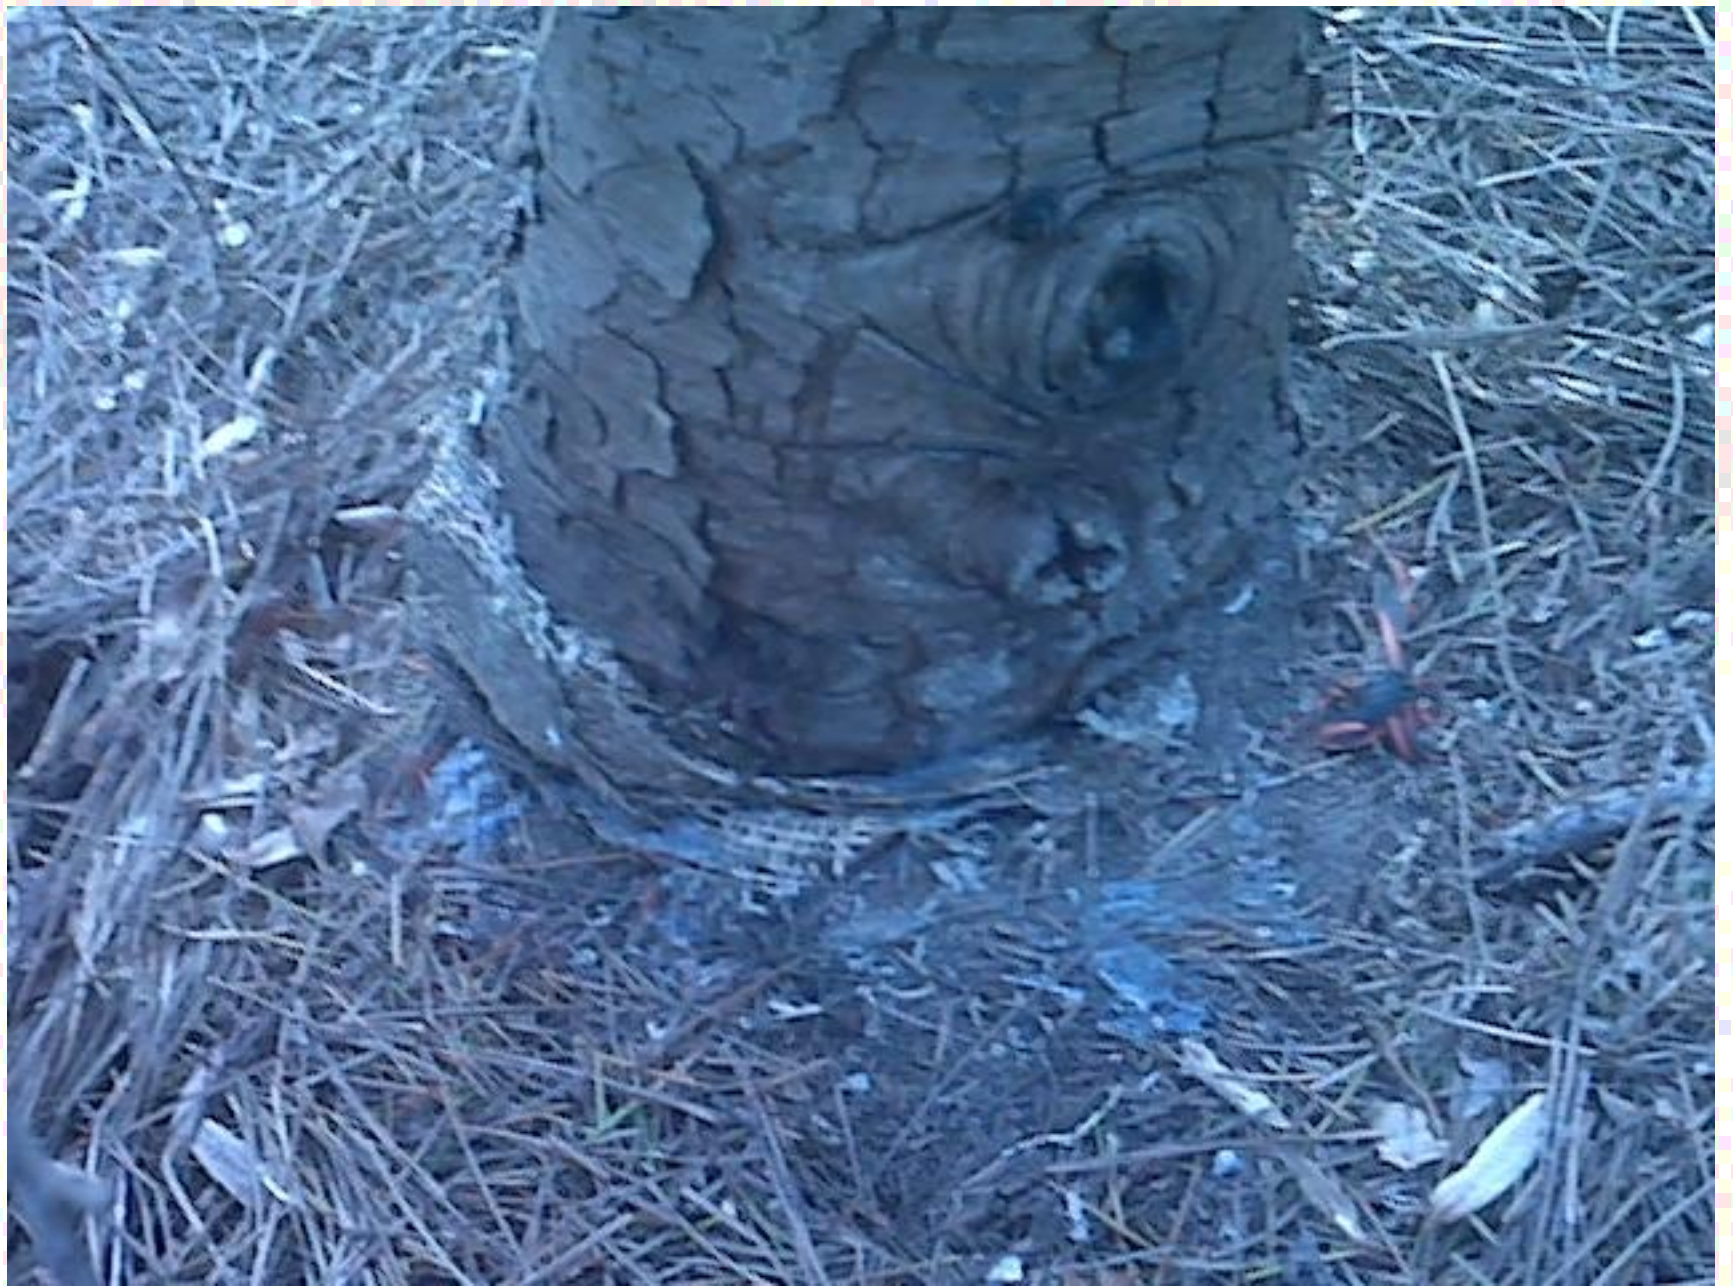
The larger trees planted in the formal landscape have not been properly treated. In many cases the synthetic burlap was left tied to the tree trunk. In several cases the shipping straps have never been removed. This is pervasive throughout the property on the larger trees.

The planted landscape trees should have their root crowns excavated to decrease the chance of disease. This process removes the burlap from the top of the rootball and removes the shipping straps. Root crown excavation also helps to remove some of the excess soil on those trees that are planted too deep. After the excavation process is completed the next step would be to soil inject a bio root stimulant to encourage new root development. Fertilizers can also be applied to increase canopy growth. The shot hole fungus is treated with fungicide and properly timed pruning. A regular spray program should be used to prevent the spread of this disease as well as to continue to protect the boxwoods from leaf minors.

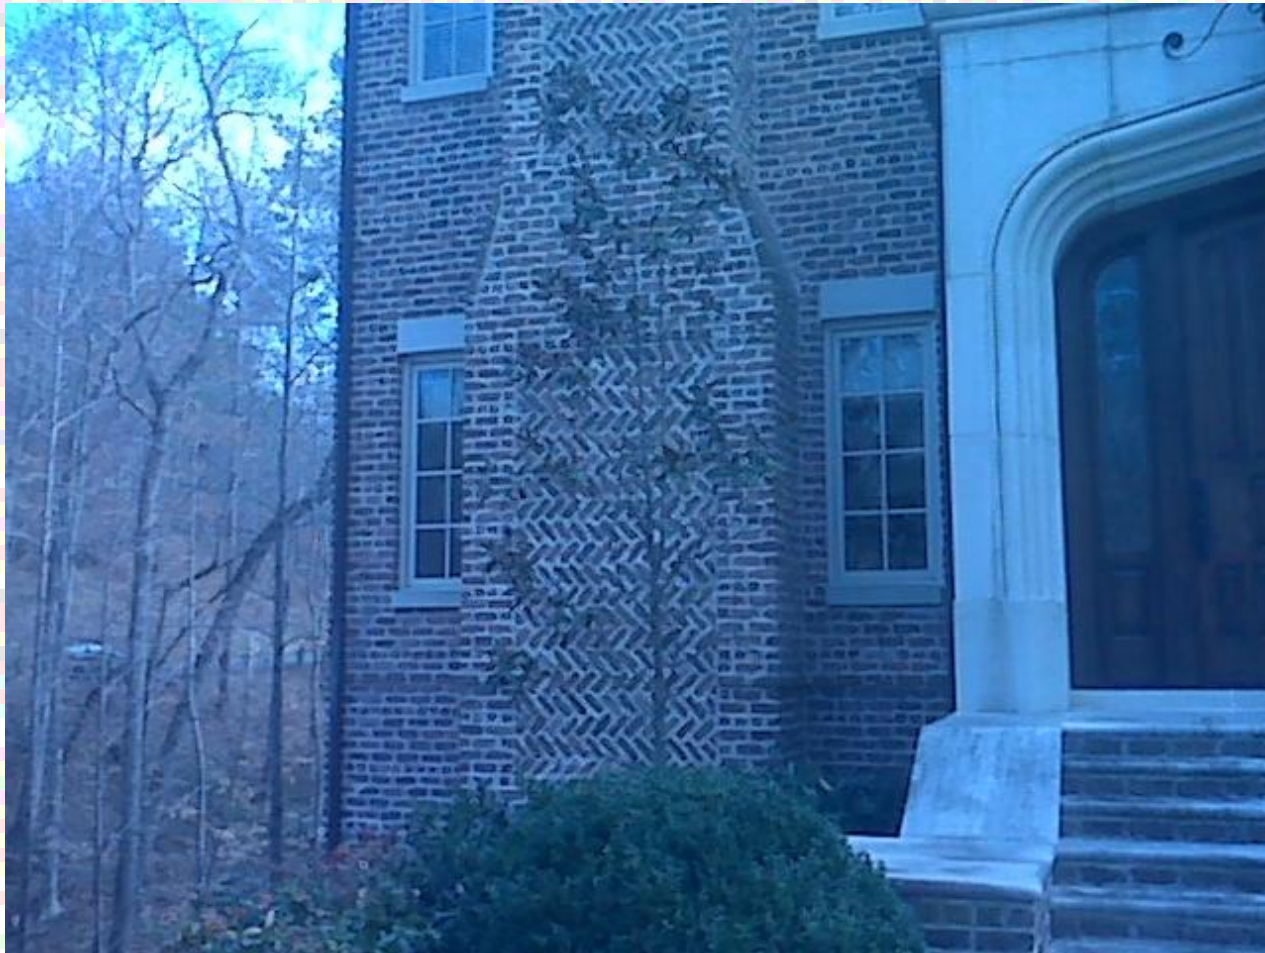
The magnolia planted next to the front entrance area is very thin. This can be caused by one or a combination of situations. Normally this is associated with too much water in the soil, however the soil was dry on the day of observation. This can also be caused by chronically dry soils. The third possibility is just a genetically poor specimen.

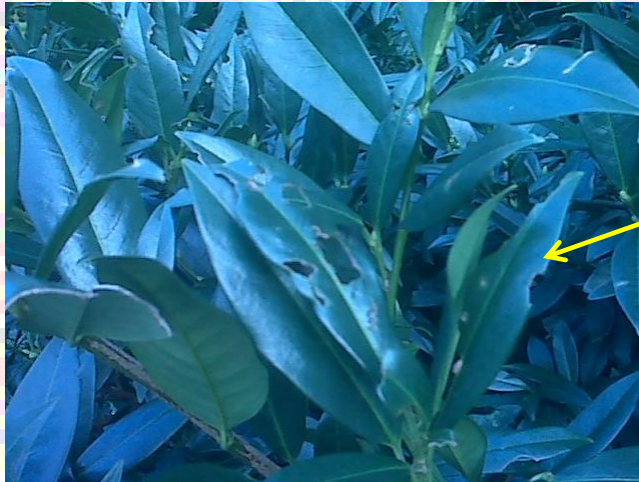
Shot hole fungus causes the leaves of this shrub to appear to have been chewed by an insect.

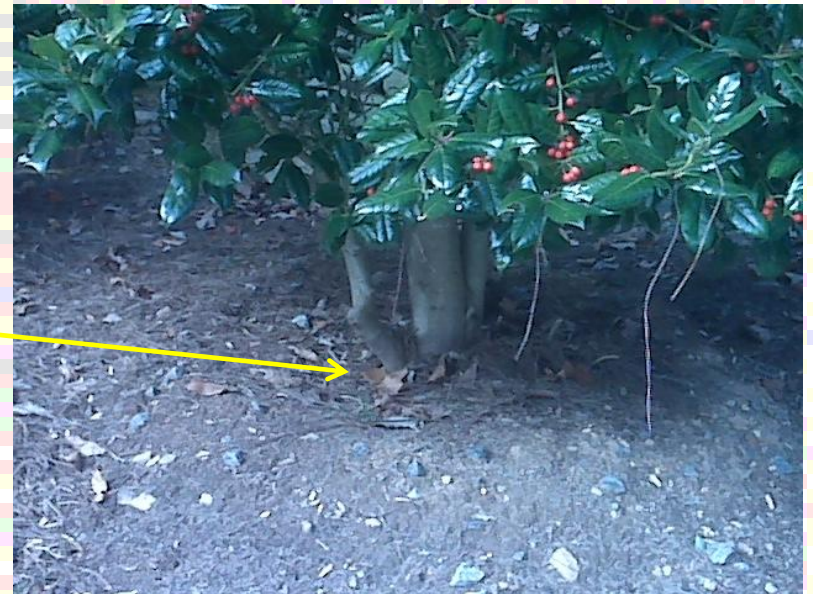
These hollies have been planted too deeply.
